# **CHAMBERLAIN HOUSE**

# HISTORIC STRUCTURE REPORT

Women's Rights National Historical Park Seneca Falls, New York

August 2001

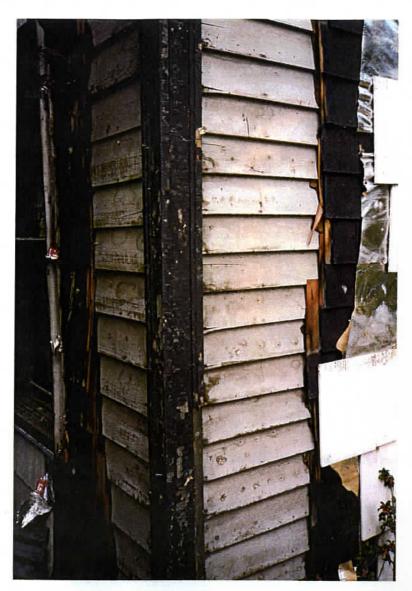
Figure 22.

Chamberlain House, southeast corner, October 1998 (left). Note early board siding on the south (left) side, and later clapboard siding on the east (right) side.

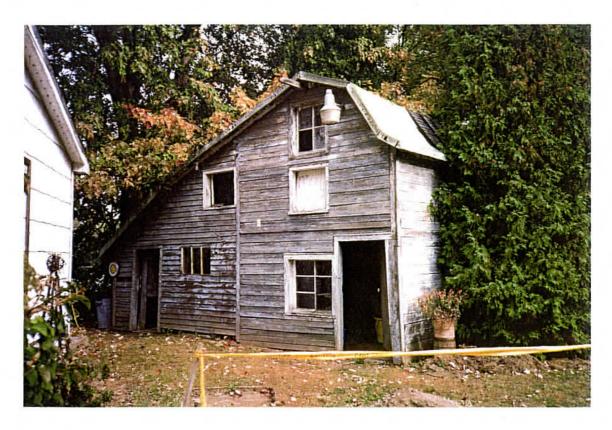
The small barn on the site is of 20<sup>th</sup>-century construction and is therefore considered to be non-historic. It is in poor repair, with the back side of the roof collapsing and open to the weather. While "no trespassing" signs have been posted, the building nevertheless poses a safety hazard and should be demolished.

Figure 24. Twentieth-century barn on the Chamberlain-House property, October 1998.

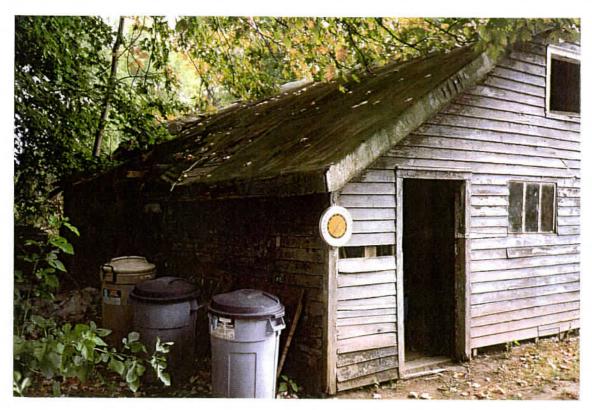
Figure 25. Back hen-house portion of the barn, October 1998.

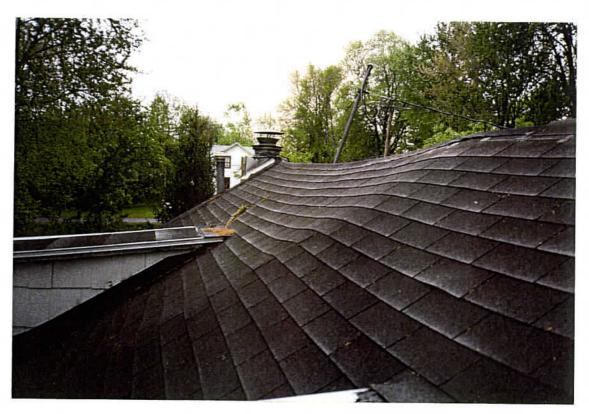
Figure 26. Roof of the Chamberlain House looking east, May 2001.

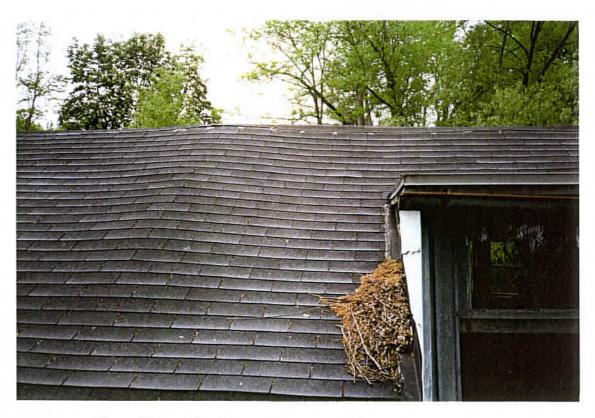
Figure 27. North slope of the Chamberlain-House roof, May 2001.

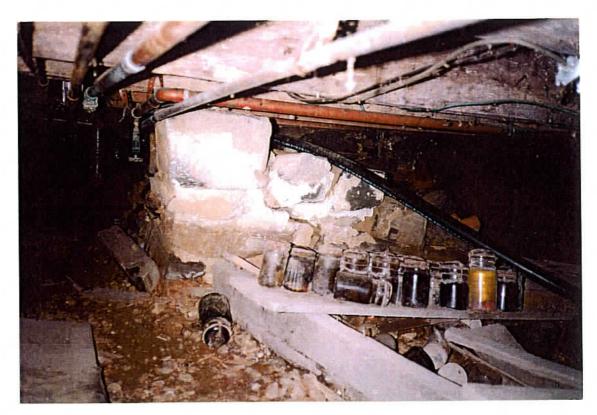
Figure 56. Chamberlain House, early chimney base in the cellar crawl space, May 2001.

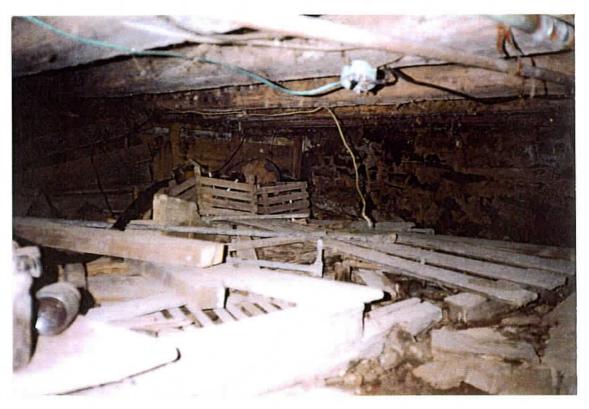
Figure 57. Chamberlain House, cellar crawl space, view looking southwest, May 2001.
